Investigation of the Roosevelt Road Transmitter Site, Fort Richardson, Alaska, Using Ground-Penetrating Radar

Lewis E. Hunter, Allan J. Delaney, and Daniel E. Lawson

March 1999

Prepared for
U.S. ARMY ALASKA

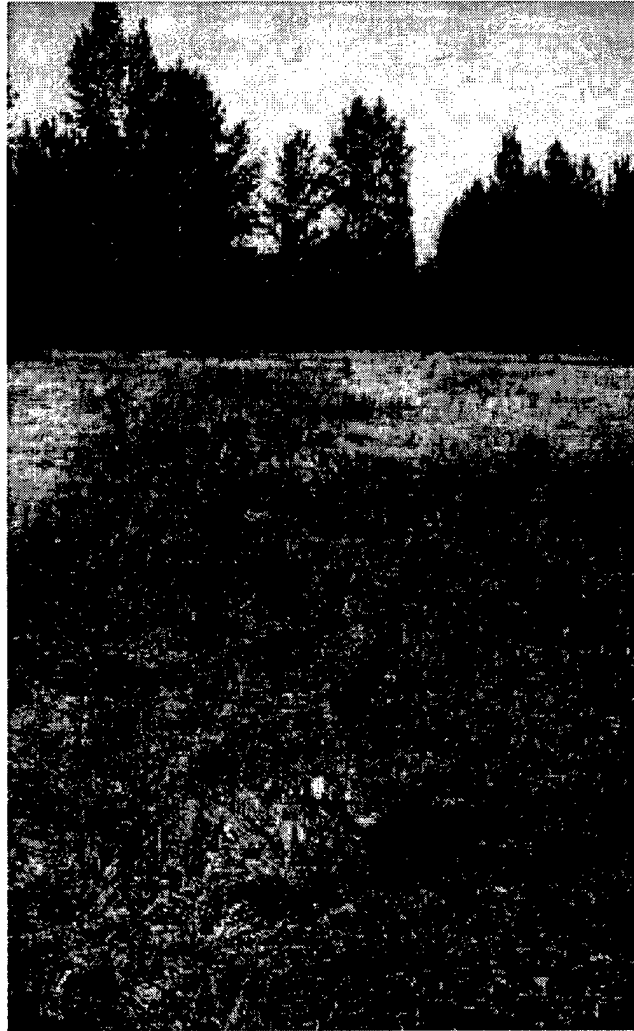
Figure 4. Holes in ground surface caused by collapse of an underground utilidor.

The Roosevelt Road Transmitter Site is located on the northern side of the Elmendorf Moraine, about 1 km southeast of the Eagle River Flats and 3 km north of the main cantonment of Fort Richardson. The bunker and transmitter annex are located on a level, low-relief ridge at an elevation of 78 m above sea level. A gravel road, two large concrete foundations, four small concrete pads, and one concrete cesspool are located above ground (Fig. 2). A second cesspool is buried west of the bunker. The area was cleared of trees during site operations (Fig. 3). Following decommissioning, the site has revegetated with alder and cottonwood. Growth is especially thick along the western edge of the bunker. Two sinkholes occur there (Fig. 4); their openings are about 0.6 m square and expose the concrete walls of utilidors. Railroad ties in the utilidor ceiling had collapsed, possibly because of heavy vehicle traffic during the 1988 and 1992 remediations. The thick overgrowth limited the westward extent of our radar analyses (Fig. 5). Other sinkholes were observed along the eastern and western edges of the transmitter annex foundation, and the utilidor extending from the annex to a power hut to the north.

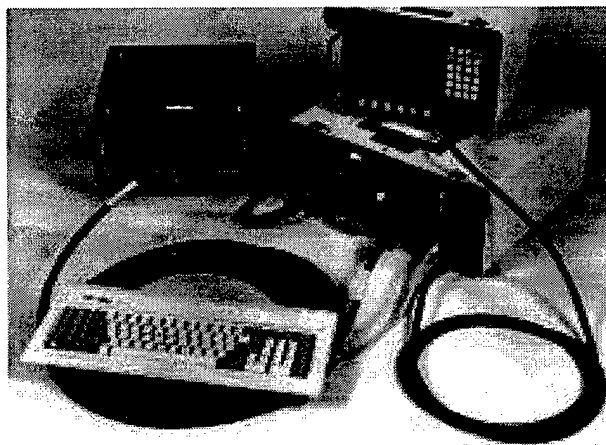
Figure 7. GSSI ground-penetrating radar system, video display, and 400-MHz transducer with cables.

Our GPR system consists of a digital control unit (GSSI System 10+) and transducer manufactured by Geophysical Survey Systems Inc. (GSSI) of North Salem, New Hampshire (Fig. 7). The radar control unit was set to trigger pulses at a selected repetition rate of 50 kHz during the study. The received radar signals were sampled in progressive time steps and converted to audio frequency scans for display and storage at a rate of 32 scans per second. The scans were digitally stacked to improve signal quality and reduce the amount of stored information. Each recorded scan

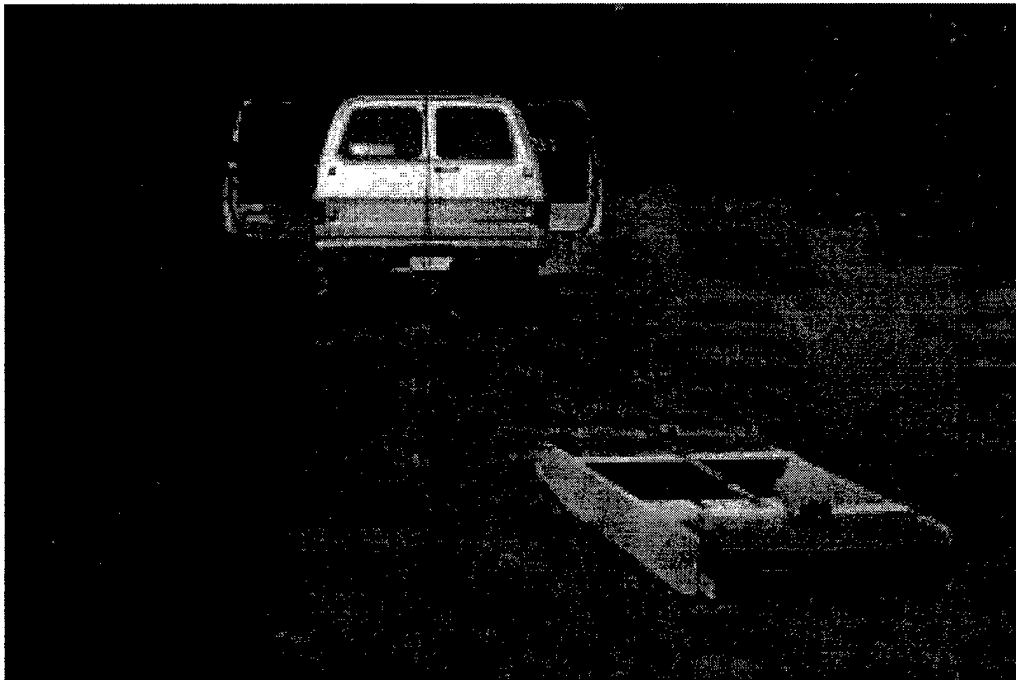
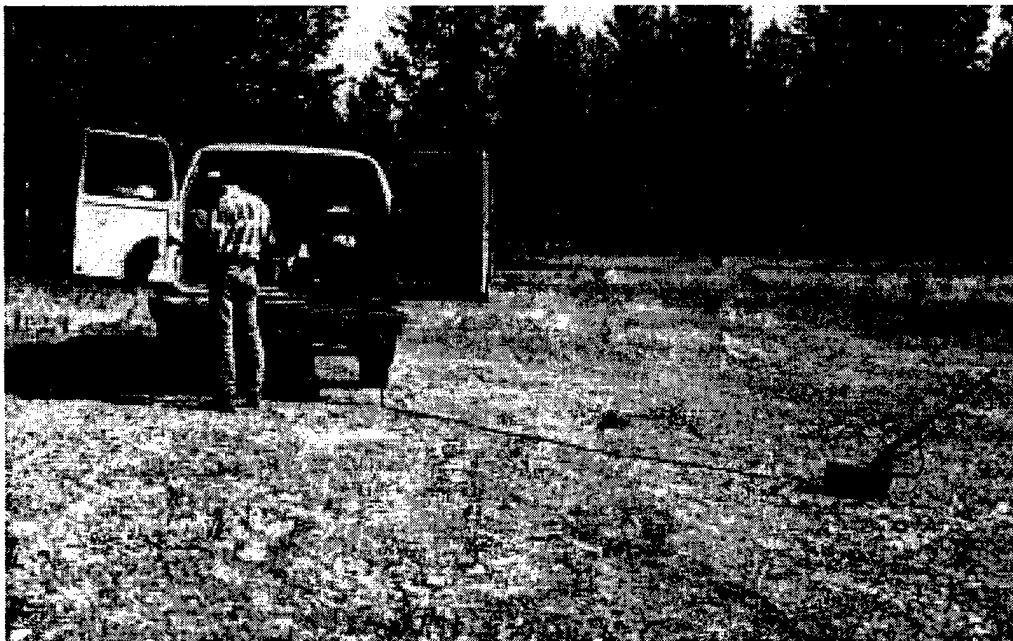
Figure 8. Towing of antennas behind 4-wheel drive vehicle.

a. 100-MHz transducer.

b. 400-MHz transducer.

We used 100- and 400-MHz shielded dipole pairs of antennas (Fig. 8) that radiate pulses with 20- and 5-ns duration, respectively. Signals from the 400-MHz transducer were recorded at a time range of 50 ns, while deeper horizons were investigated using the 100-MHz transducer at a time range of 300 ns. Antennas were towed along the

ground surface by hand or behind a 4-wheel drive vehicle (Fig. 8). The survey speed was approximately 1 m/s to maintain a close contact with the ground surface and to maximize signal transmission through the air/ground interface. This speed provided a profile data density of about 16 scans for each meter of transducer travel. Profile data were later filtered to remove noise and horizontally scaled between event markers to compensate for uneven towing speed.

The site was surveyed during the summer of 1996, when the ground surface was dry. The control unit and data recorder were operated from the front passenger seat of a 4-wheel drive vehicle and powered directly from the vehicle's electrical system. The 100-MHz transducer was placed in a wooden sled to reduce abrasion on the bottom of the antennas and was towed approximately 10 m behind the vehicle (Fig. 8a). The smaller 400-MHz transducer was pulled by hand to maintain good contact between the antenna and the ground surface (Fig. 8b).
